Restoration Diary: Boston & Maine Coach 1246

David Woodbury

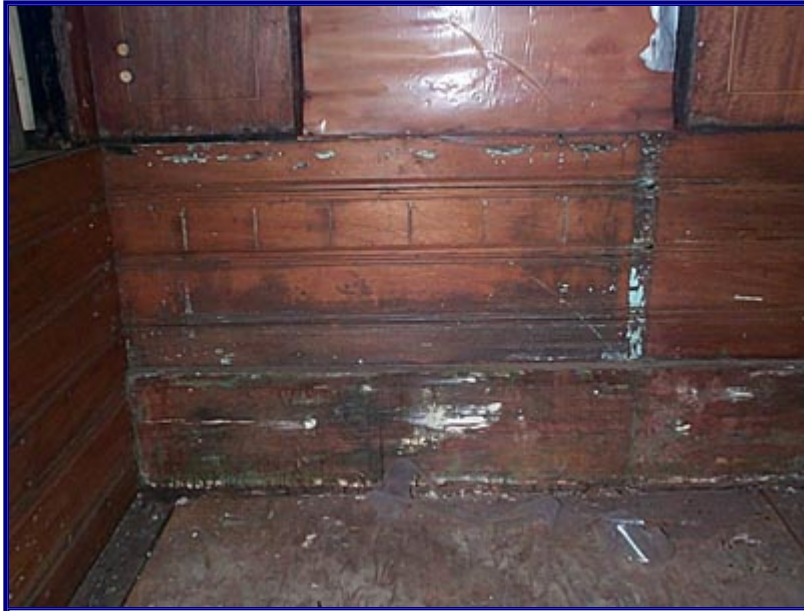
Original wainscoting and base board patched with plaster of Paris, evidently a Steamtown fix. Reasonably effective under paint, but not acceptable with a clear finish.

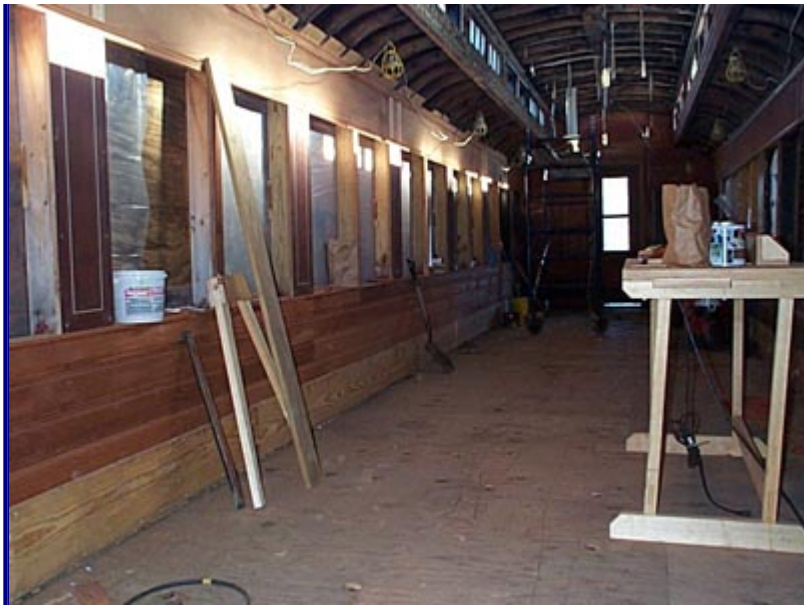
View down the length of the car showing the all new "bad" side and the original "good" side.

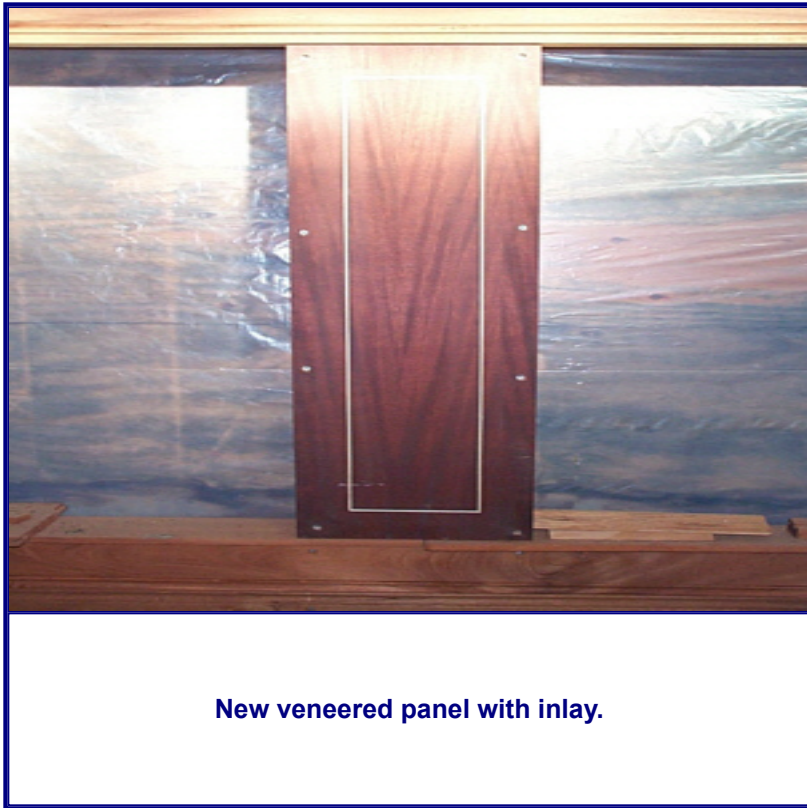
New veneered panel with inlay.

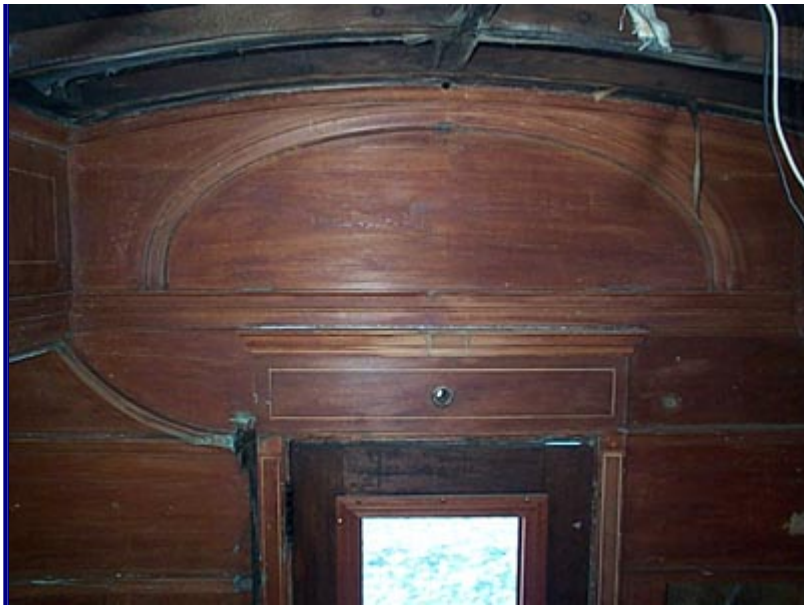
End area at the roof line. Elliptical panel is hinged at the bottom and originally let down to give access to the Pintsch lamp over the platform. It has been nailed shut since electrification in the twenties. To try and open it now would cause unnecessary damage. Note the remains of the saloon ceiling to the lower left. That curve will be hard to replicate accurately.
