The Continuing Saga of ex-Boston & Maine Coach No. 1246 (Part IV)

story by David Woodbury

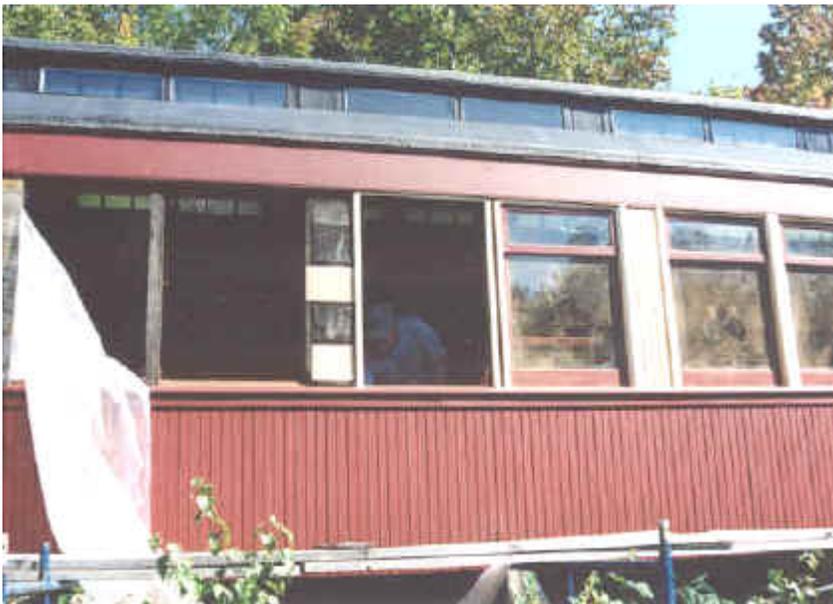
Peeling back the plywood and plastic bit by bit gives a chance to install the outer stops and siding without too much exposure to a

*sudden rain storm. Notice the sawdust all over the window panes.
Photo by Gary Luneau.*

and some of it had a grain that wasn't straight enough so there was a small amount of waste. That's where the stove kindling comes from. After a day or so, I had a supply of blanks made up and it was time to open up the plywood which had been covering the windows for the past four years. One last task lay ahead. I needed some siding for the wide piers of the same size as the siding below the belt rail that I had put on years earlier. I wasn't impressed with the behavior of the original yellow poplar and wanted to try a different product. I settled on MDO, an exterior smooth paintable plywood. It advertised as millable and durable to the elements if painted. The sign industry uses it extensively. It isn't too expensive, but weighs a ton. I milled up a couple of sheets and painted the raw edges as recommended. It milled up well without the voids found in ordinary plywood. It nailed on more easily than the poplar and made a good appearance. Only time will tell if it's truly as durable as advertised.

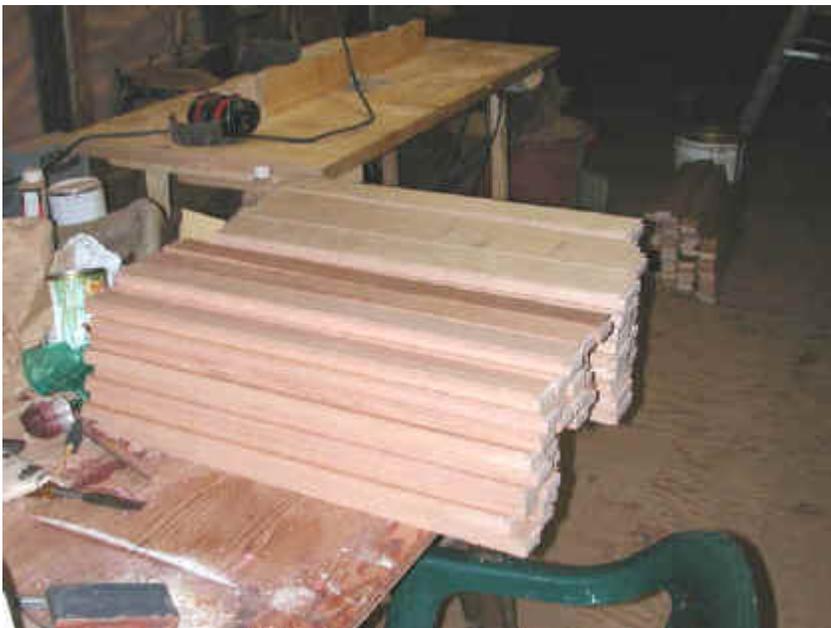
This is where you begin. A pile of blanks waiting for the router, glue up, painting, glazing and finishing. Photo by David Woodbury.

The original windows had a combination of rounded bead and mortise and tenon joint that I could find no equivalent for in any of the woodworking tool catalogues. There are plenty of router cutters to make raised panels and frames for cabinets, but fewer which could be adapted for glass. These left a joint that relied on gluing to end grain, not reliable and strong. The compromise I came up with was to use this joint and reinforce it with a hardwood dowel driven into the joint and glued. This would provide the functional equivalent of the missing mortise and tenon. With the plan in place, it remained to take the blanks for the first forty and finish them. This was not complex with the stile and rail cutter, but involved handling 160 pieces either once or three times depending on the piece. Then comes the glue-up. This requires a jig to make sure the corners are square with a series of wooden wedges to provide the clamping force. The jig I made would only handle two windows at a time. The glue manufacturer stated that clamping time would only a half hour, but I preferred to leave the windows clamped overnight. In theory, it would take twenty days to clamp them up and it about did. Of course, I could do other things to the glued-up windows as the process unfolded. Those other things included sanding, inserting the dowels and painting the outer surface with primer and two coats of exterior paint.

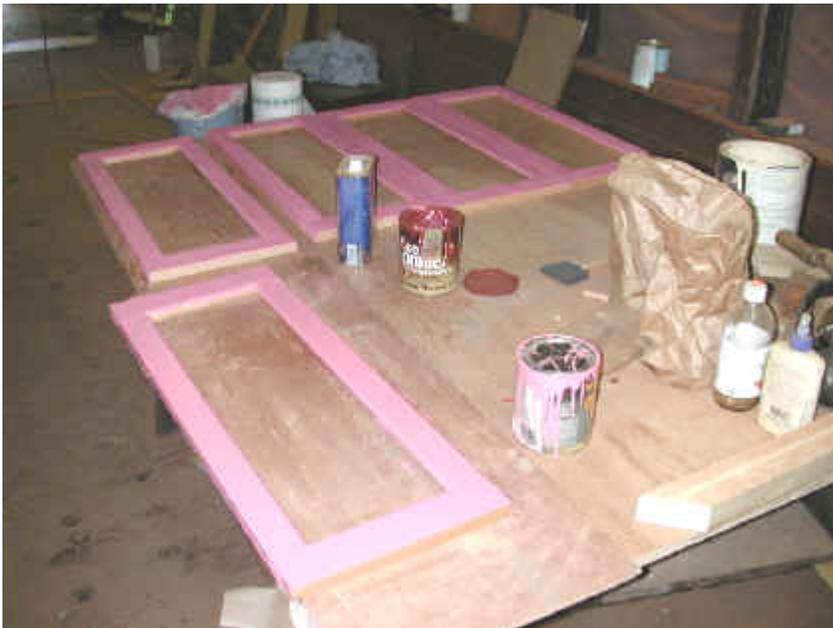
No, this isn't the final window color. It shows how wrong the hardware store can go tinting paint. It's perfectly useful as an undercoat. Photo by David Woodbury.

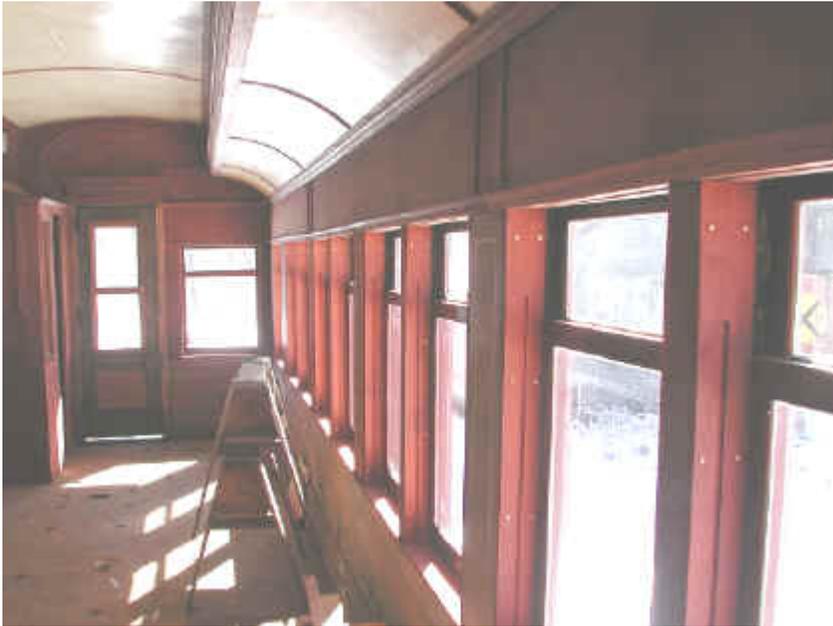
This is the interior after clean up. It's gone from dark and gloomy to light and even warm on sunny days. Photo by David Woodbury.

When I pulled off the plywood, the interior of the car went from gloomy and dark to light in an instant. I only pulled off as much plywood as I could replace with windows at any one time so the transformation wasn't complete right away. In fact it took me another month or so to install the windows on one side.

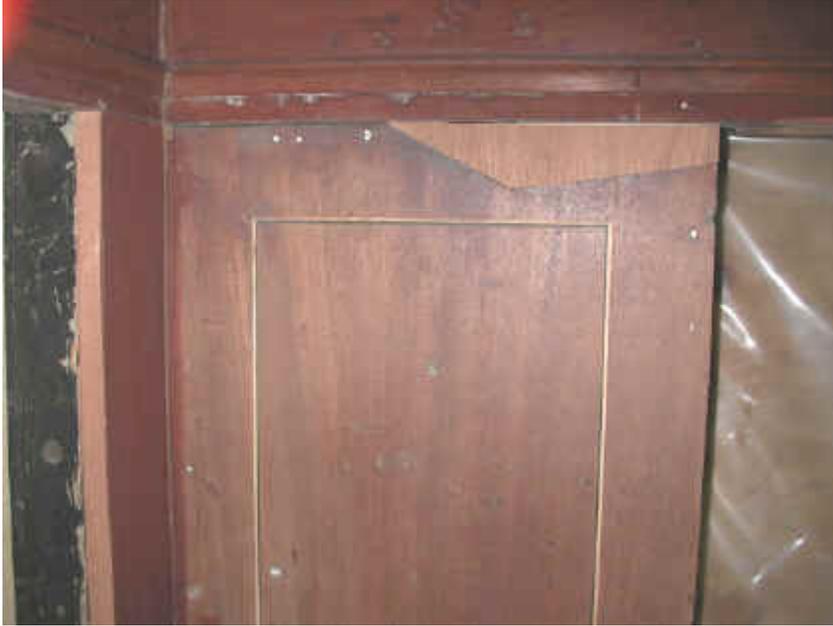
This is repaired veneer. Modern mahogany veneer isn't as highly figured as the original. When stained and filled, it blends in well enough. The patch in this picture is not yet stained. Photo by David Woodbury.

During the summer while windows were gluing or paint drying, I tried repairing water damaged veneer. The panels between the windows and between the clerestory windows were of a mahogany veneer with a line of marquetry inlay. I had torn out and replaced those too badly damaged, but about half were salvageable if patched. New veneer was easily available as was the underlayment for those places where the damage went below the veneer itself. The only trouble was that Pullman had used a premium figured veneer which while still available was both very expensive and not available in large enough sheets for my purposes. Under the circumstances, I used the regular veneer and by making a pattern

and cutting out the damaged areas, I could make a decent repair that after staining and filling would look good.

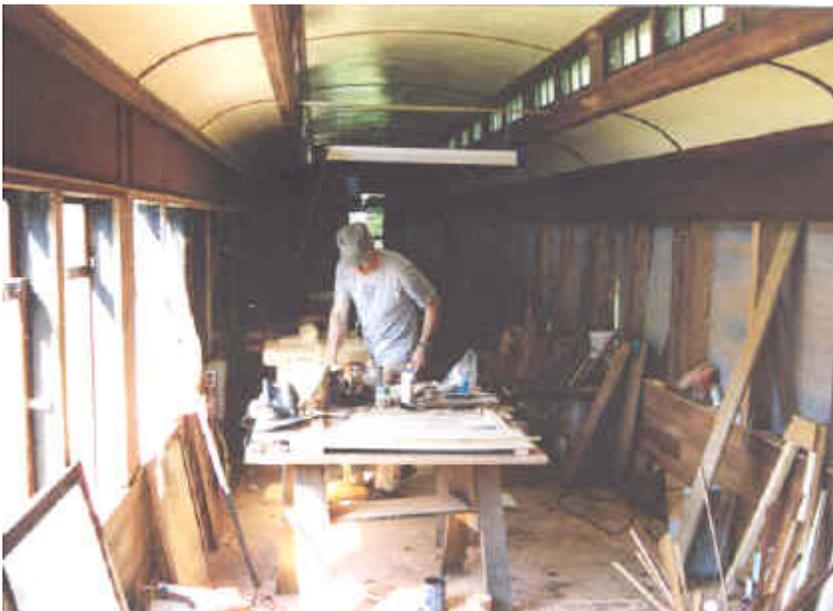
Toward the end, the clutter and mess got overwhelming. One day I had to stop work and take a couple of trips to the landfill. Photo by

Gary Luneau.
